May 20, 2019

Westwind at Vail HOA
c/o Mr. Steven MacDonald
President
Vail Management Company
P.O. Box 145
Vail, Colorado 81658

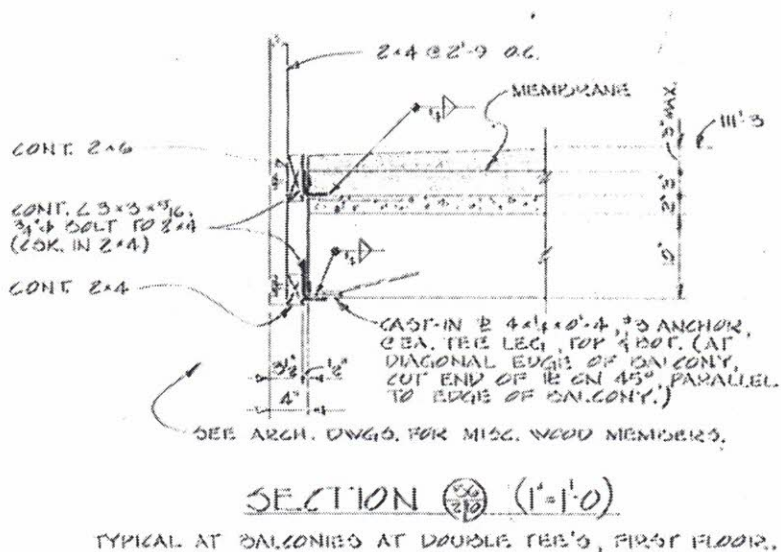
Figure 1. Section through first floor balcony (*Structural Drawings*).

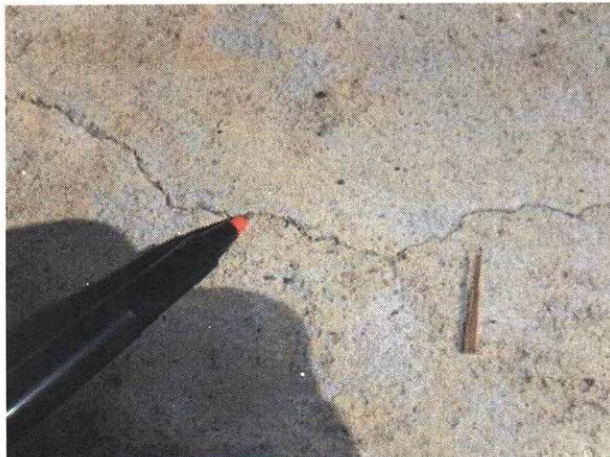
Photo 2: Crack in concrete topping slab.

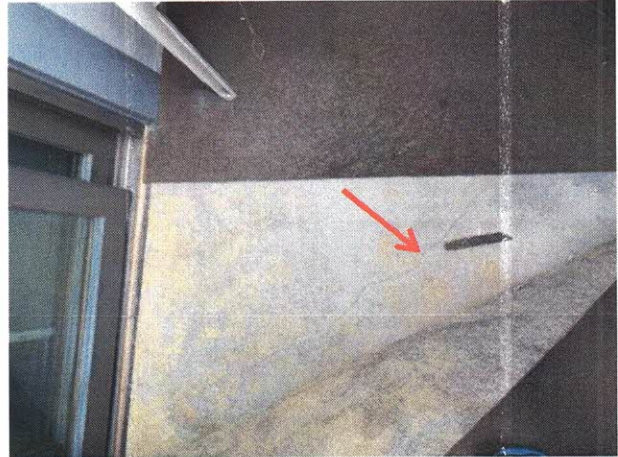
Photo 3: Crack in concrete topping slab below carpet covering. Note yellow residue from failed adhesive.

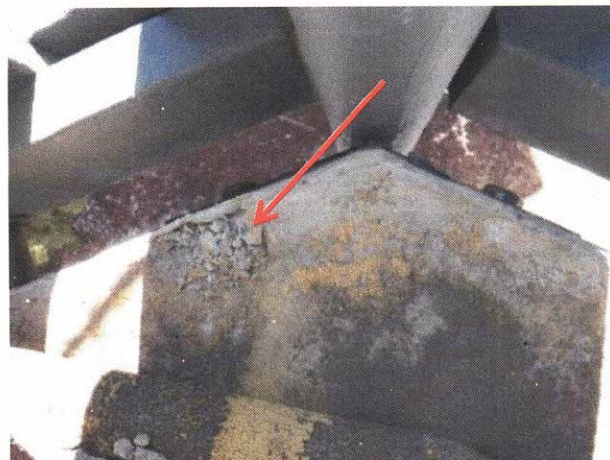
Photo 4: Concrete deterioration at edge of concrete topping slab.

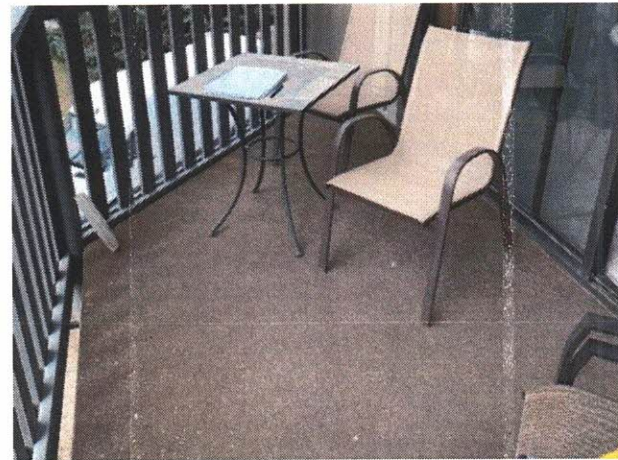
Photo 5: Balcony with carpet covering.

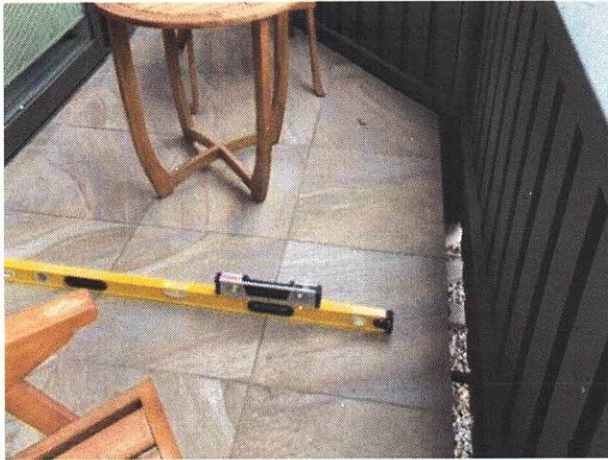
Photo 6: Tile installed over concrete topping slab.

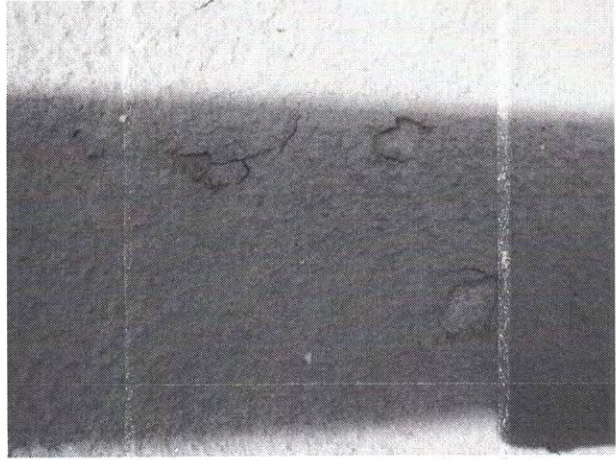
Photo 7: Minor deterioration of wood trim adjacent to balcony. Note the balcony at this location has been coated.

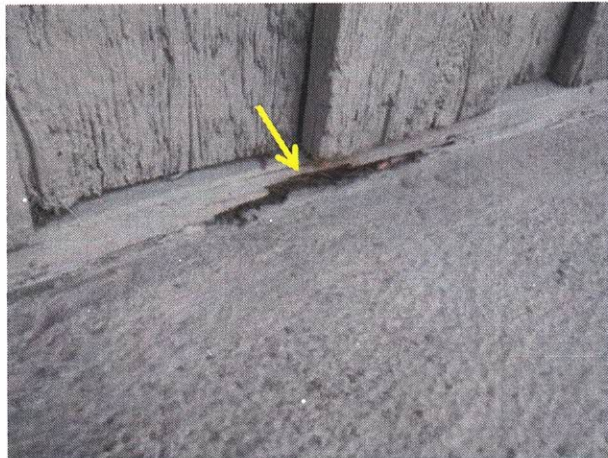
Photo 8: Deterioration of wood trim adjacent to balcony. Note the balcony at this location has been coated.

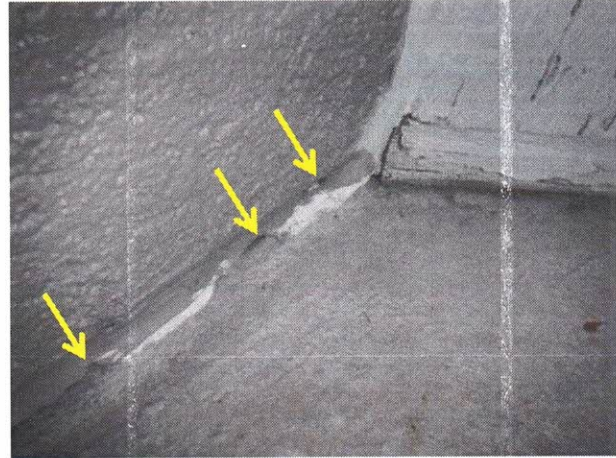
Photo 9: Gaps in perimeter joint sealant.

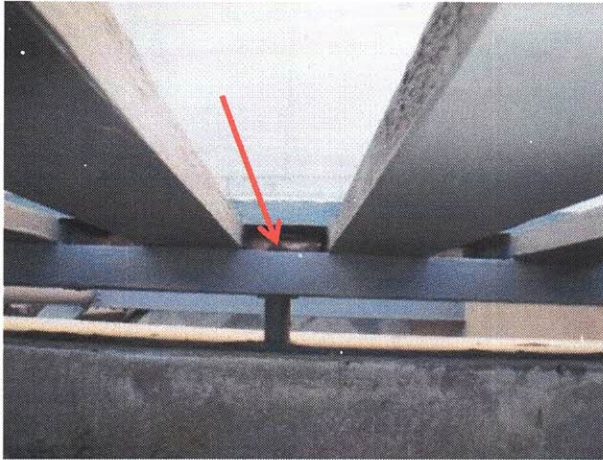
Photo 10: Guardrail is attached through face of rim joists (typical).

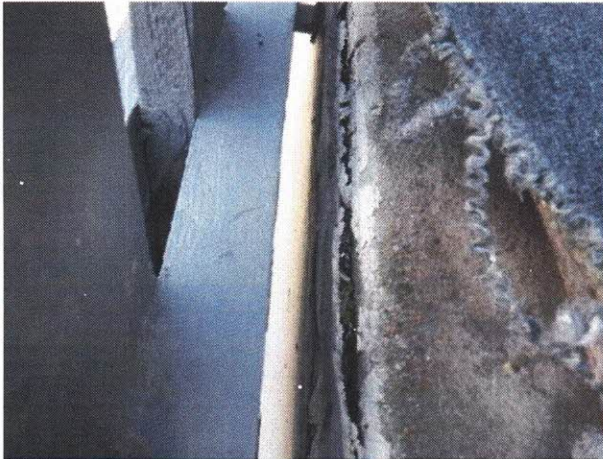
Photo 12: Deteriorated joint sealant at edge of balcony.

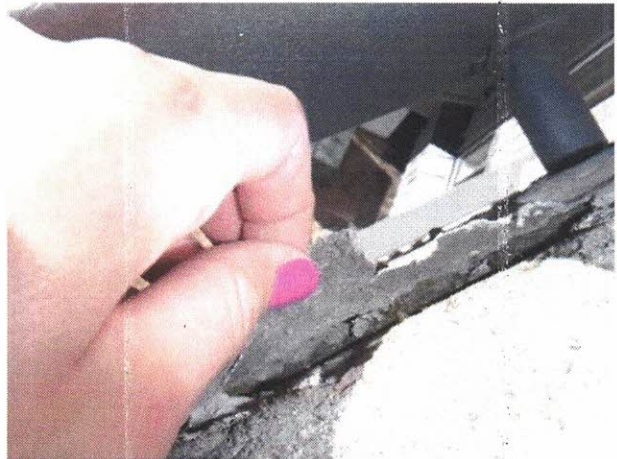
Photo 13: Deteriorated joint sealant at edge of balcony.

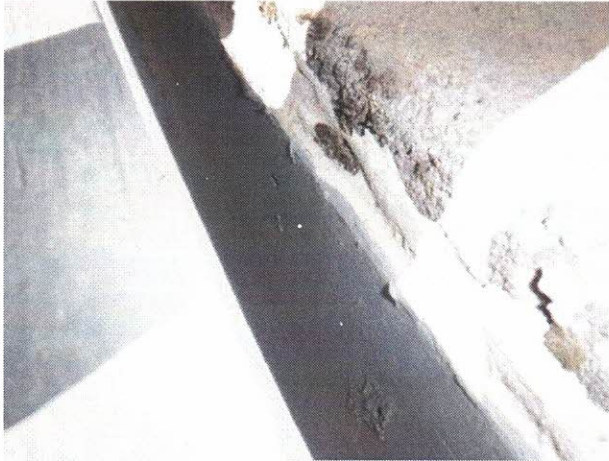
Photo 14: Deteriorated joint sealant at edge of balcony.

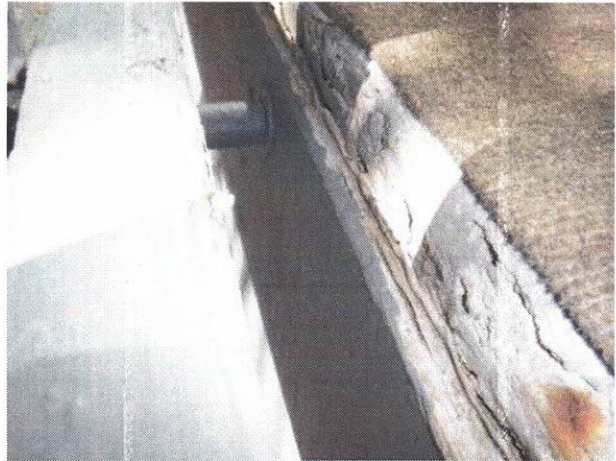
Photo 15: Deteriorated joint sealant at edge of balcony.

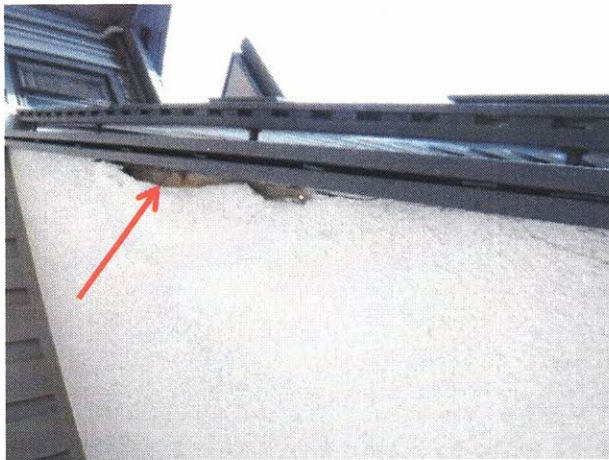
Photo 16: Popcorn finish at soffit is deteriorated.

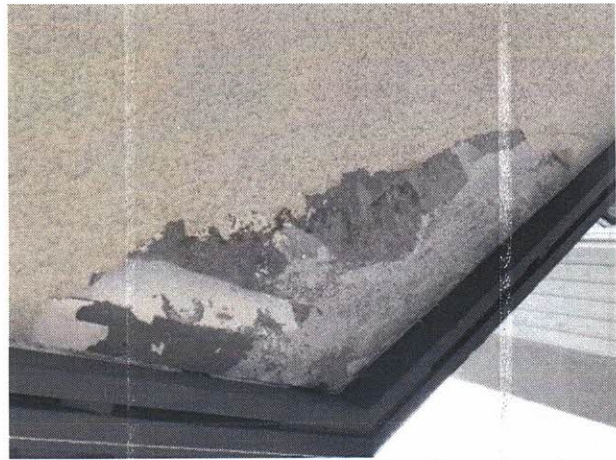
Photo 17: Popcorn finish at soffit is deteriorated.

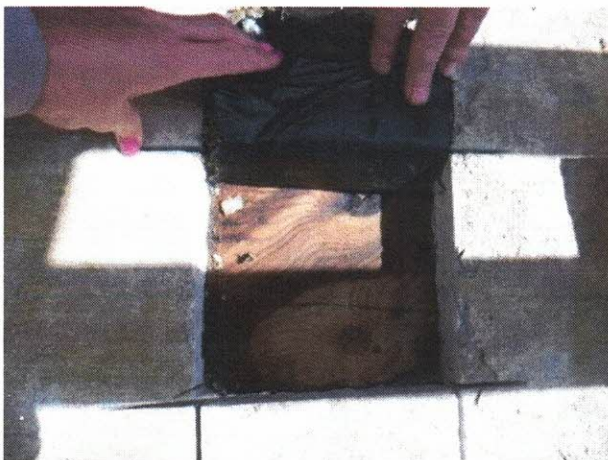
Photo 18: Exploratory opening into concrete topping slab. Note the presence of a black membrane over the plywood sheathing and staining on the sheathing. (Unit 404)

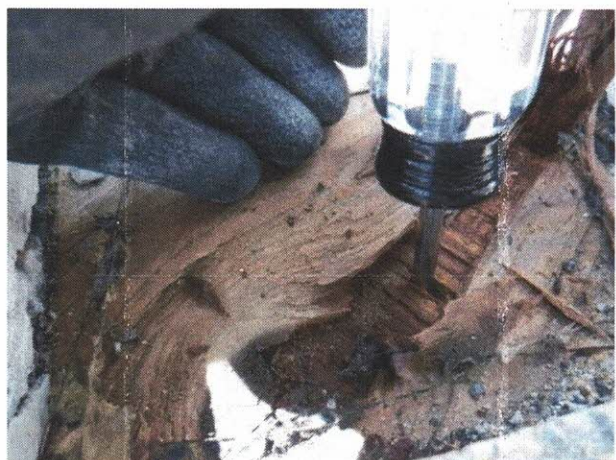
Photo 19: Awl was able to penetrate through the plywood sheathing with little force. (Unit 404)

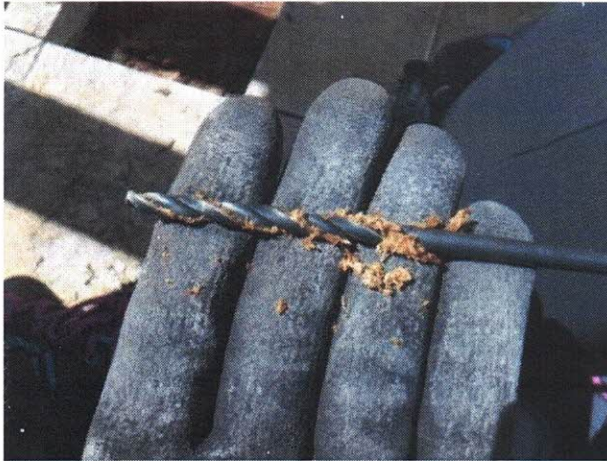
Photo 20: Plywood shavings are moist and soft. (Unit 404)

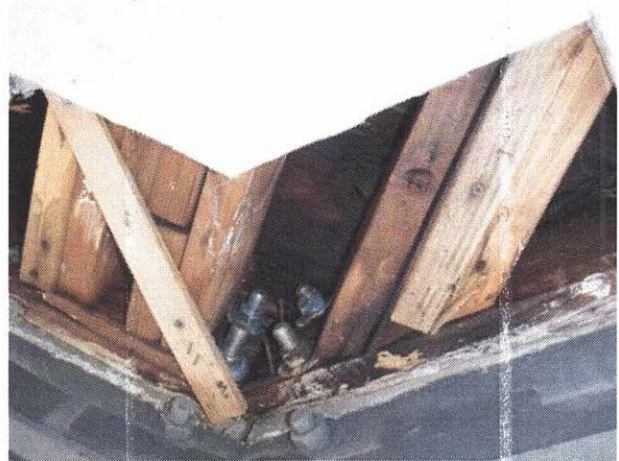
Photo 21: Exploratory opening into soffit. (Unit 304)

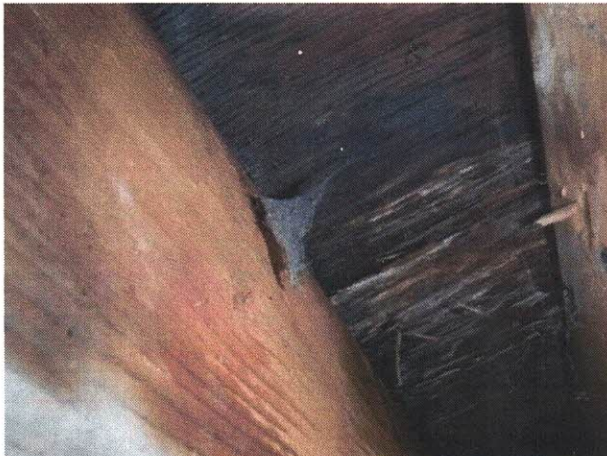
Photo 22: Plywood sheathing is heavily stained, almost black at all visible areas. (Unit 304)

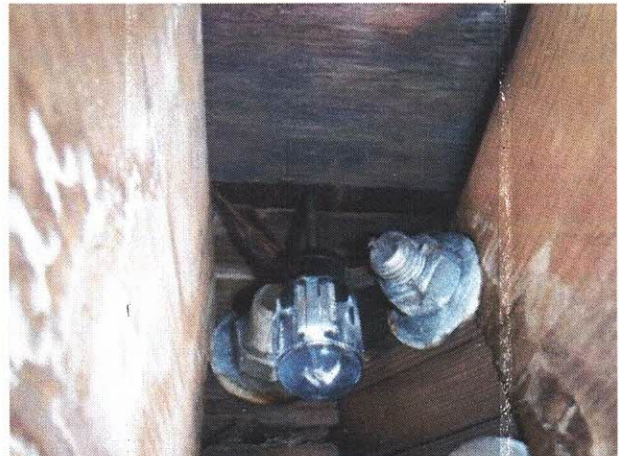
Photo 23: Awl was able to penetrate through the plywood sheathing with little force. (Unit 304)

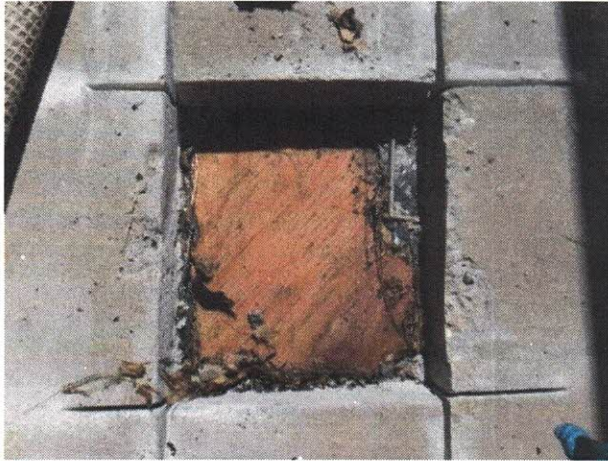
Photo 24: Exploratory opening into concrete topping slab. Note lower right-hand corner of sheathing is stained. (Unit 407)

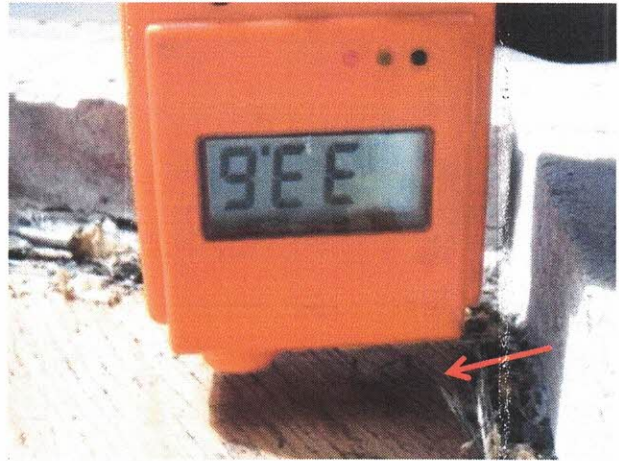
Photo 25: Moisture content reading of 33.6 percent at plywood sheathing. (Unit 407)

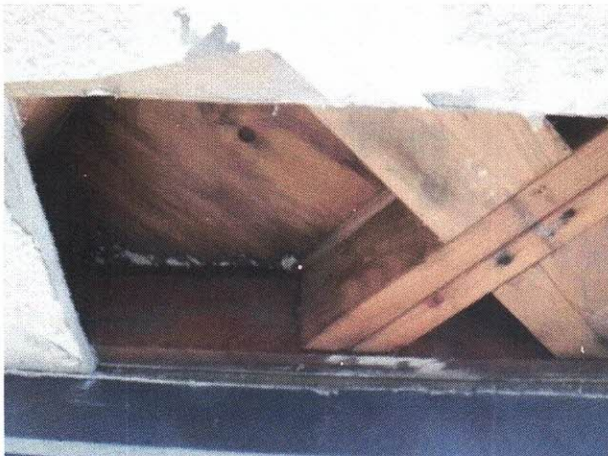
Photo 26: Exploratory opening at soffit. (Unit 302)

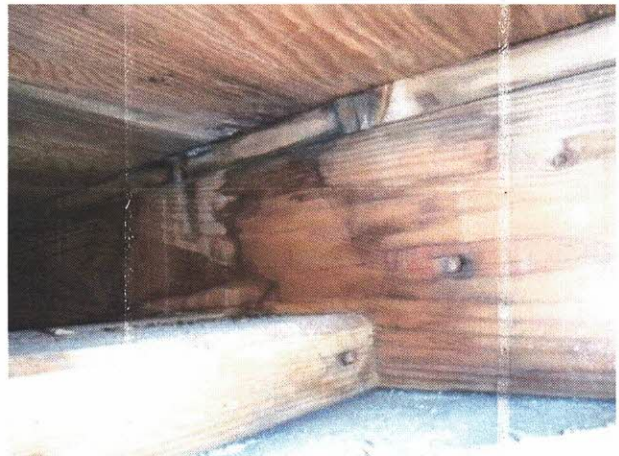
Photo 27: Staining is apparent on sheathing and joists. (Unit 302)

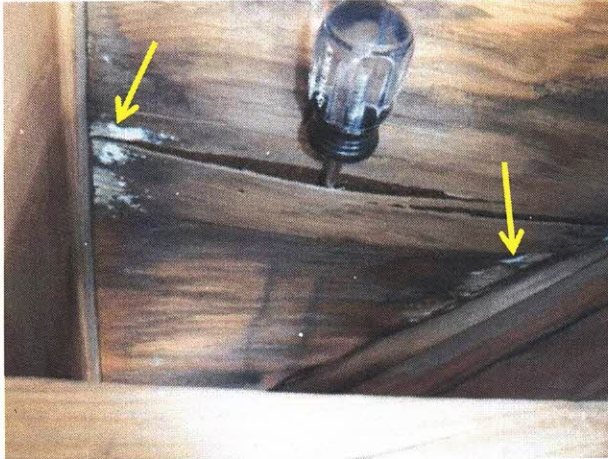
Photo 28: Organic growth is present on the plywood sheathing (arrows) and the outer layer of the sheathing is no longer bonded. (Unit 302)

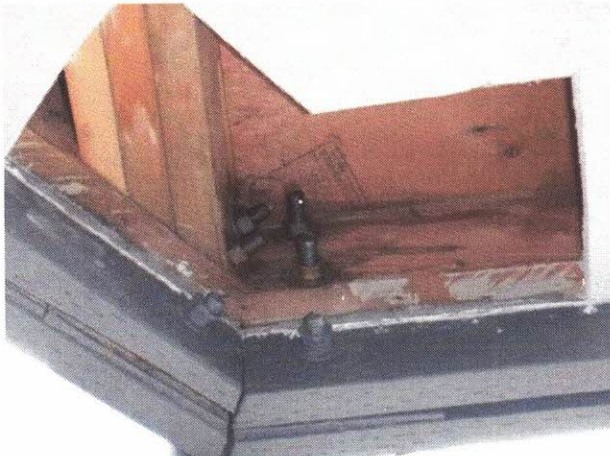
Photo 30: Exploratory opening at soffit. (Unit 209)

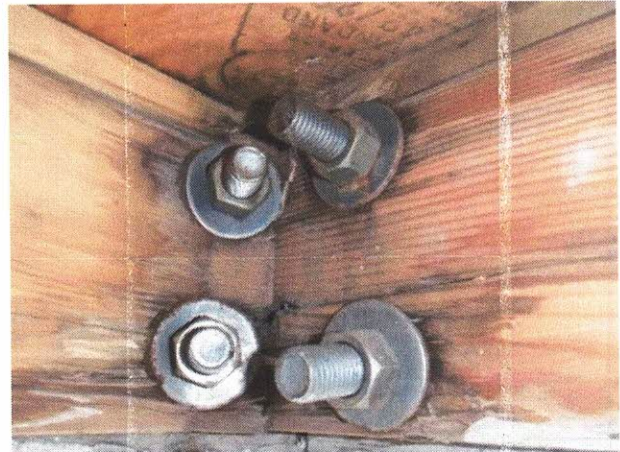
Photo 31: Staining around bolts connecting balcony to column. (Unit 209)

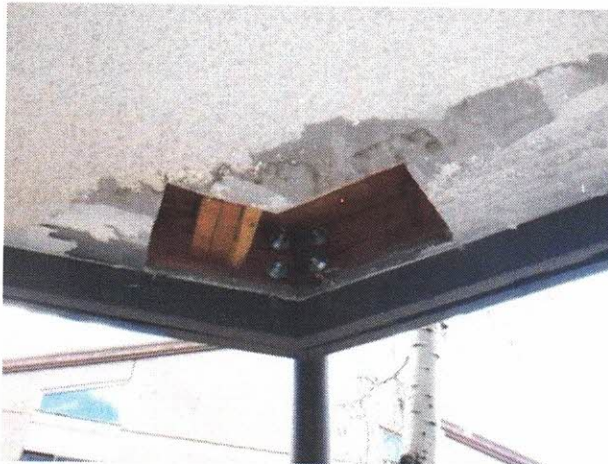
Photo 32: Exploratory opening at soffit. (Unit 201)

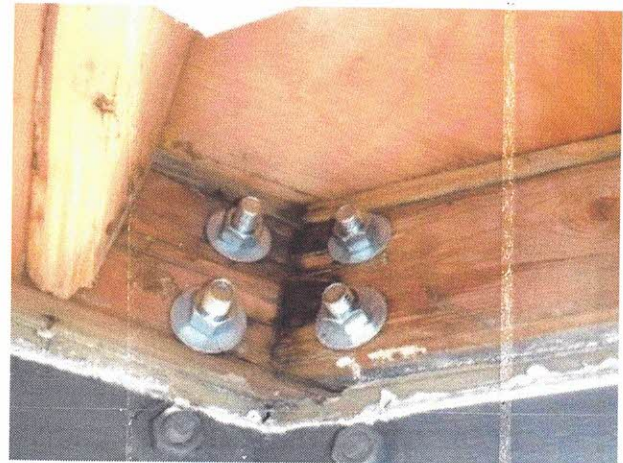
Photo 33: Staining around bolts connecting balcony to column. (Unit 201)

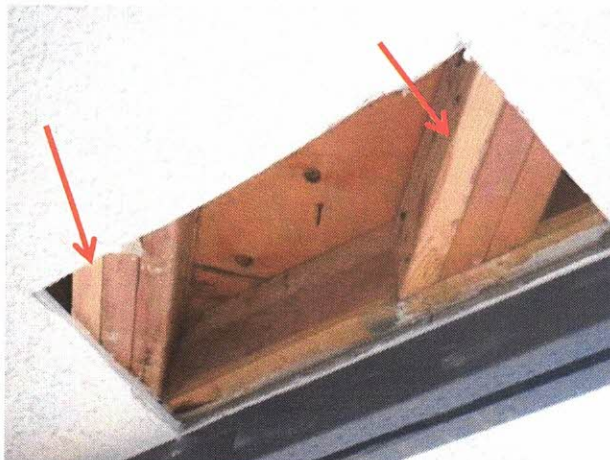
Photo 34: Exploratory opening at soffit. Note sistered joists (arrows). (Unit 104)

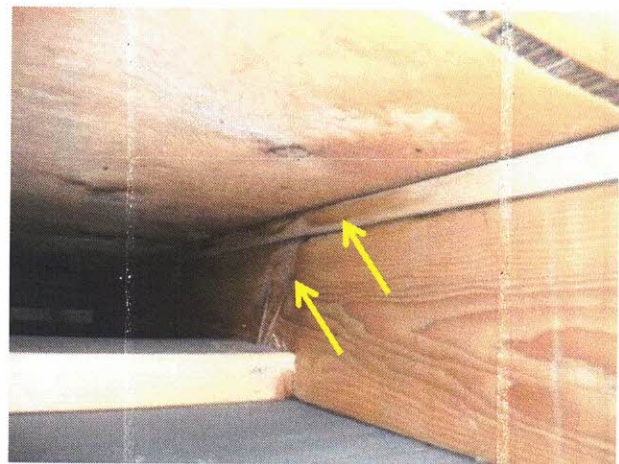
Photo 35: Minor staining is present on sheathing and joists.

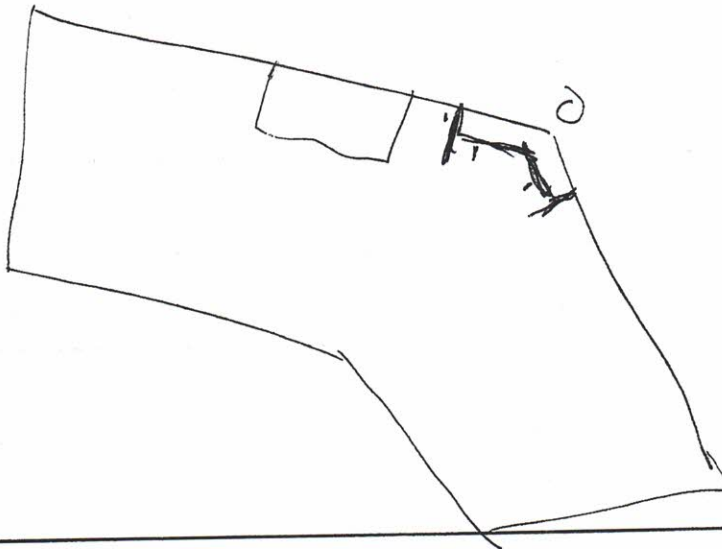
③ Unit 407 → at spalled edge adjacent to post.
