Westwind
Vail, CO

Report #: 54845-0
Beginning: August 1, 2025
Expires: July 31, 2026

RESERVE STUDY
"Full"

July 29, 2025

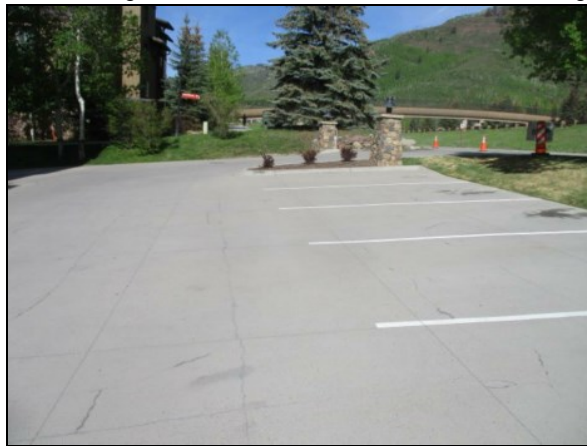
Comp #: 21050 Snowmelt Driveway Concrete - Replace

History: Replaced in 2020.
