Westwind
Vail, CO

Report #: 54845-0
Beginning: August 1, 2025
Expires: July 31, 2026

RESERVE STUDY
"Full"

July 29, 2025

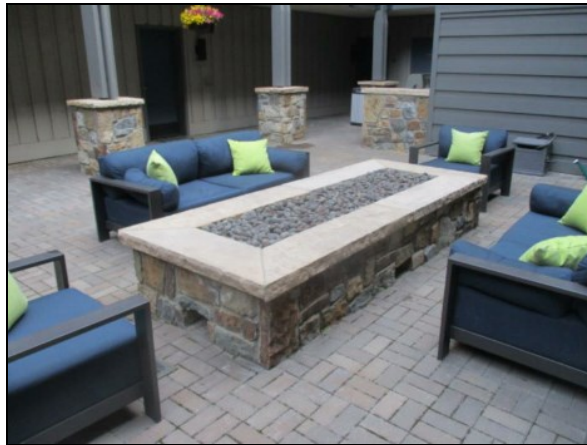
Comp #: 29380 Fireplace - Replace

History: Replaced in 2020.

Comments: Minimal or no subjective/aesthetic value for this component. Useful life is based primarily on normal expectations for service/performance life in this location. Unless otherwise noted, remaining useful life expectancy is based primarily on original installation or last replacement/purchase date, our experience with similar systems/components, and assuming normal amount of usage and good preventive maintenance. Fireplaces should be inspected and evaluated regularly by servicing vendor. In some cases, replacement is warranted due to lack of available replacement parts, or to upgrade to more efficient technology. Treat routine repairs/maintenance as an Operating expense. Plan for replacement at the typical service life expectancy indicated below. Useful life can often be extended with proactive service and maintenance. Unless otherwise noted, funding for system with same size/capacity as the current system.

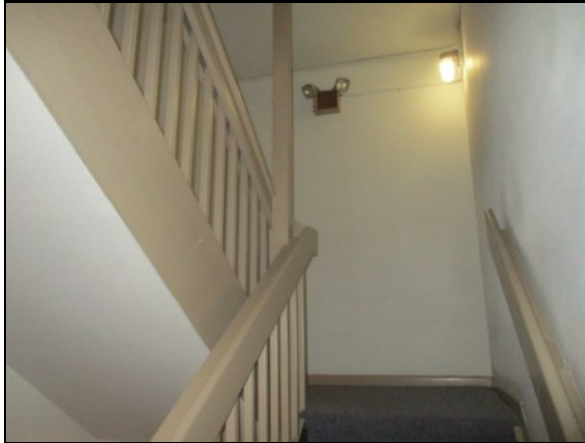
Comments: Includes (3520 GSF) Surfaces, (100 GSY) Carpet. The finish on the surfaces appeared in generally poor condition. Evidence of cracking, fading, and peeling of the paint was observed. Plan to paint the surfaces soon. No structural issues were reported to us by the client at the time of the inspection. We recommended setting aside reserve funds to supplement the operating budget for local repairs in future years. As routine maintenance, inspect regularly and perform any needed local repairs promptly as general maintenance expense. Ensure that tread connections are tight, secure and slip resistant. Paint components regularly along with building interiors.

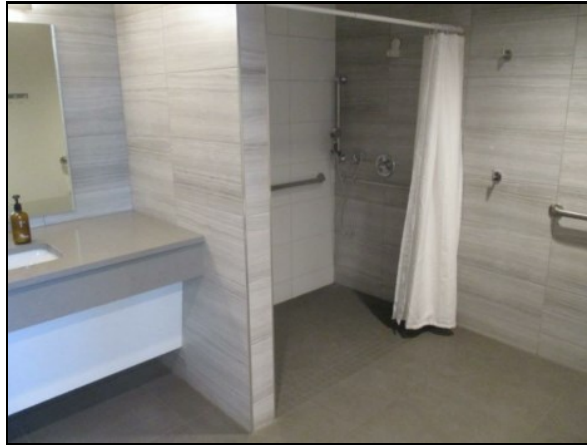
Comments: Includes (400 GSF) Tile, (1400 GSF) Surfaces, (600 GSF) Ceiling, (1) Drinking Fountain. Fitness rooms determined to be in fair condition typically exhibit routine signs of wear and age. Flooring typically shows some deterioration but remains consistent overall and provides good cushion/support for users. Furnishings may be slightly dated at this stage but are still functional and serviceable. Fitness room should be remodeled at the approximate interval shown here in order to maintain good appearance and functionality. In our experience, the scope of work for remodeling may include replacement or addition of some or all of the following: flooring, lighting, mirrors, water fountains, TVs, etc. Unless otherwise noted, costs are based on replacement of like kind and quantity, and does not factor in any major structural or other sub-surface changes. In our experience, best practice is often to coordinate remodeling with other projects, such as remodeling of other amenity areas, or with replacement of exercise equipment.

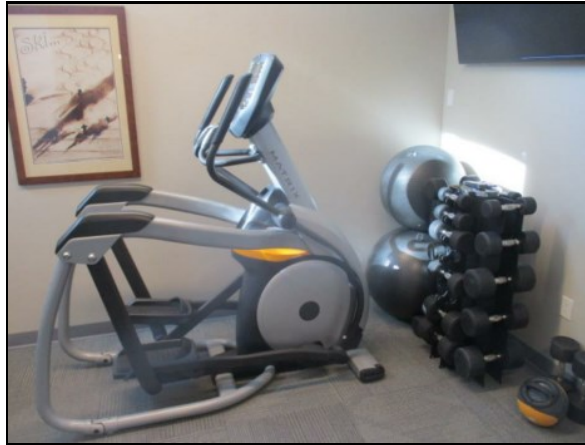
Comp #: 24150 Fitness Equipment (All) - Replace

Comments: Includes (1) Multi-machine, (1) Elliptical, (1) TV. Equipment was not tested at time of inspection and our observations do not make any judgement about safety of the equipment. In our experience cardio equipment tends to have a shorter useful life overall than strength equipment due to reliance on more electronic components more moving parts and obsolescence due to advancements in technology. Inspect regularly clean for appearance maintain and repair promptly as needed from Operating budget to ensure safety. Best practice is to coordinate replacement of all equipment together to obtain better pricing and achieve consistent style and quality. Unless otherwise noted costs are based on replacement with similar quality standard and quantity/types of equipment.

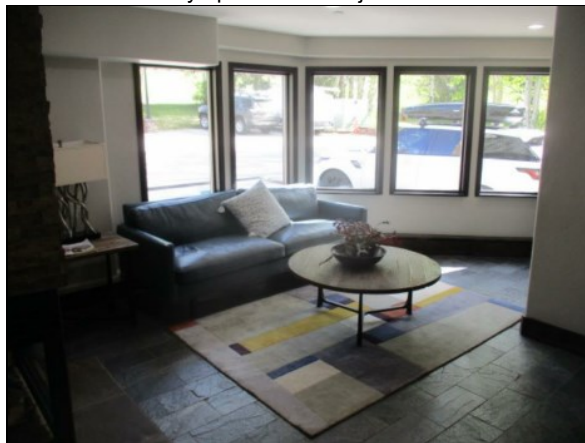
History: Replaced in 2023.

Comments: Includes (2) Leather Chairs, (1) Leather Couch, (1) Coffee Table, (1) Side Table. The furniture and decor appeared in fair condition. No damage fading or outdated appearances of the furniture was observed. This component recommends funding for periodic replacement/refurbishment of interior furnishings and decor such as furniture artwork window treatments misc. decorative items etc. in order to maintain a desirable aesthetic in the common areas. Cost estimates can vary greatly depending on the amount of items to be replaced at each project and the style and quality of replacement options. Best practice is to coordinate this type of project with other interior projects such as flooring replacement painting etc. Schedule and cost estimates should be re-evaluated during future Reserve Study updates and adjusted as needed based on the client's good judgment.

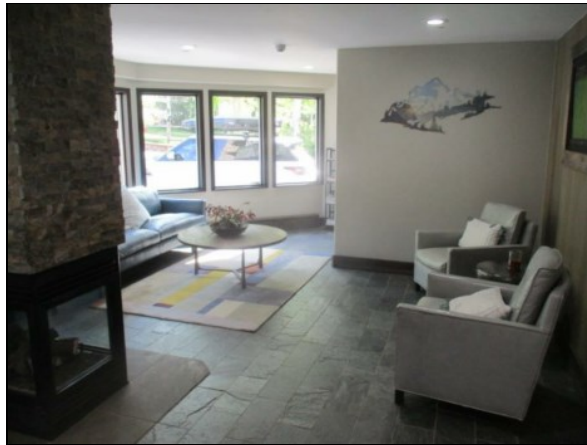
Comments: Includes (625 GSF) Tile, (1000 GSF) Surfaces, (625 GSF) Ceiling, (1) TV, (8 LF) Base Cabinet, (16 GSF) Countertop, (16 GSY) Carpet, (480 GSF) Surfaces, (144 GSF) Ceiling. Lobby was observed to be in fair condition. Flooring was mostly clean and free of any major issues. Fixtures appeared to be in good condition. Lobby remodeling is prudent in order to maintain an attractive desirable appearance for existing owners as well as potential buyers and other guests. Typical projects often include replacement of finishes and furnishings artwork lighting etc. Life estimates can vary greatly depending on level of wear and preferences of client. Costs can vary greatly depending on types of materials selected for replacement. Many clients choose to work with design personnel to maintain a coordinated attractive aesthetic. Funding recommendation shown here is for remodeling to an appropriate standard for this client. Life and cost estimates should be re-evaluated during future Reserve Study updates.

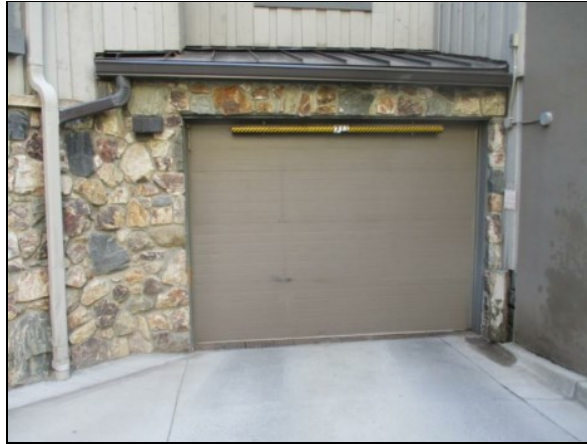
Comp #: 23490 Garage Doors - Replace

Comments: Garage doors determined to be in fair condition typically exhibit more moderate signs of physical wear and tear. Appearance is still generally consistent but declining at this stage. Garage doors should have a long life expectancy under normal circumstances. Should be inspected and repaired as-needed as an Operating expense to ensure good function. Be sure to inspect internal components (springs, tracks, etc.) for damage and deterioration. For private garages, individual owners are presumed to be responsible for replacement of the garage door opener. Doors should ideally be replaced in all areas at the same time to maintain consistent appearance and obtain better pricing through economies of scale. There are a wide variety of styles available, and costs can vary greatly. Unless otherwise noted, estimates shown here are based on replacement with type comparable to existing doors.

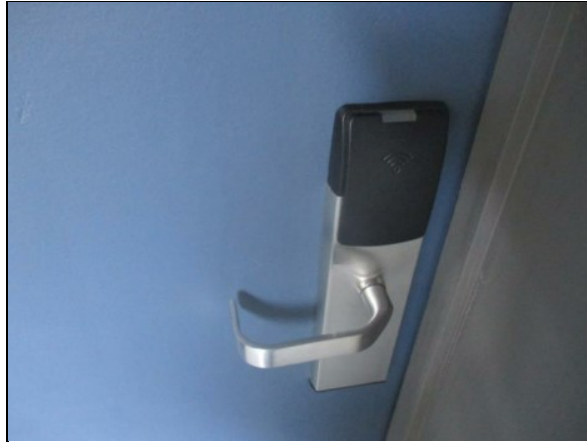
Comp #: 25020 Keycard/Fob Reader System - Replace

History: Replaced in 2021 for ~ \$42,000.

Comments: Minimal or no subjective/aesthetic value for this component. Useful life is based primarily on normal expectations for service/performance life in this location. Unless otherwise noted, remaining useful life expectancy is based primarily on original installation or last replacement/purchase date, our experience with similar systems/components, and assuming normal amount of usage and good preventive maintenance. Card/fob reader devices were/were observed to be functional during site inspection. Due to use, exposure, and advancements in technology, plan to replace devices and control system at the approximate interval shown here. Individual readers can often be replaced as an Operating expense due to damage or localized failures. To ensure a functional, compatible system and obtain better pricing, plan on replacing all devices together as one project.

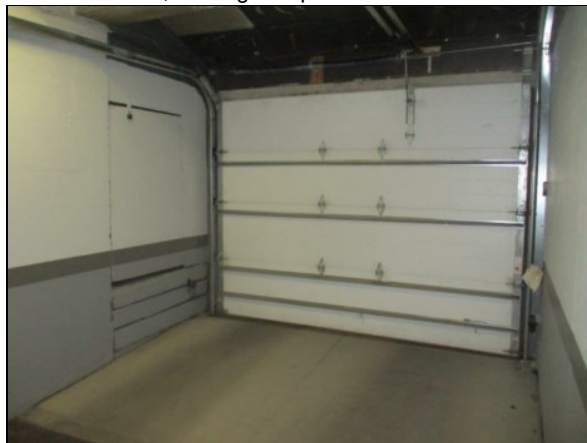
Comp #: 25060 Garage Operators - Replace

Comments: Minimal or no subjective/aesthetic value for this component. Useful life is based primarily on normal expectations for service/performance life in this location. Unless otherwise noted, remaining useful life expectancy is based primarily on original installation or last replacement/purchase date, our experience with similar systems/components, and assuming normal amount of usage and good preventive maintenance. We recommend regular inspections (including service and repair as needed) be paid through the Operating budget. Even with ongoing maintenance, plan for replacement at typical life expectancy indicated below. Useful life can vary greatly depending on level of use, exposure to the elements, etc. Monitor actual expenses closely for future Reserve Study updates. Unless otherwise noted, funding to replace with similar units.

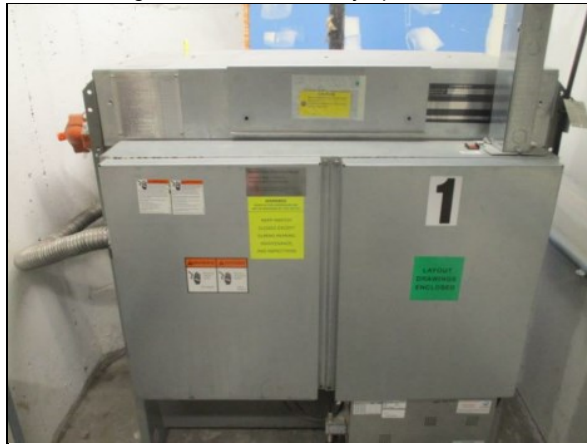
Comments: Elevators should be inspected regularly and tested as a preventive maintenance expense. This modernization project typically includes replacement/upgrade of controller(s), mechanical door components, push-button fixtures, and includes additional allowances for electrical work or fire alarm work by others, code-required changes, etc. Elevator vendors typically recommend modernization cycles of approximately 25 years for continued smooth, safe operation, technology advances and/or code changes. In our experience, actual interval is typically 20-30 years or sometimes longer, depending on level of use, maintenance, availability of replacement parts, etc. When remaining useful life is below 5 years, we recommend beginning discussions with your elevator vendor to determine the most cost effective specifications and approach to a modernization project. Modernization should be anticipated and planned for, as lead time for required parts can be months-long if done on short notice. To minimize elevator downtime, schedule the project ahead of time and consult with elevator vendor for more information. Some properties opt to hire an elevator consultant to draft a scope of work and oversee the process of obtaining estimates, and installation for compliance. Costs shown here may need to be re-evaluated depending on unpredictable electrical or fire safety code changes and should be monitored during future Reserve Study updates.

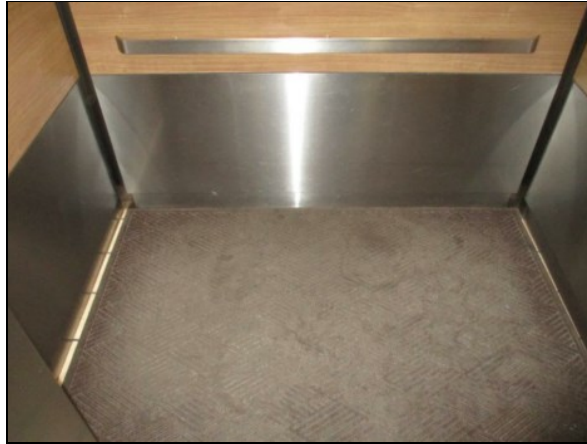
Comments: Elevator cabs determined to be in fair condition typically exhibit normal signs of wear and age, such as scuffing and surface wear to flooring and wall paneling, but remain generally clean and without any signs of advanced wear or damage. At this stage, aesthetic standards are still being upheld and cabs are aging normally overall. This component recommends budgeting for periodic remodeling of the elevator cab interior(s) to ensure good physical condition and maintain aesthetic standards of the property. Timing of this elective project is ultimately at the discretion of the client, but ideally should be coordinated with mechanical modernization to minimize downtime. Cost can vary greatly depending upon chosen design, and our estimates assume remodeling to a similar standard as currently in place. If higher quality standards are being considered, increases may need to be incorporated into future updates. A general allowance based upon our experience and consultation with elevator vendors is shown below for budgeting purposes, but any new information or cost estimates should be incorporated into future Reserve Study updates when known. Note if present, any service-only cabs are not expected to be a significant aesthetic priority and are not included here unless otherwise noted.

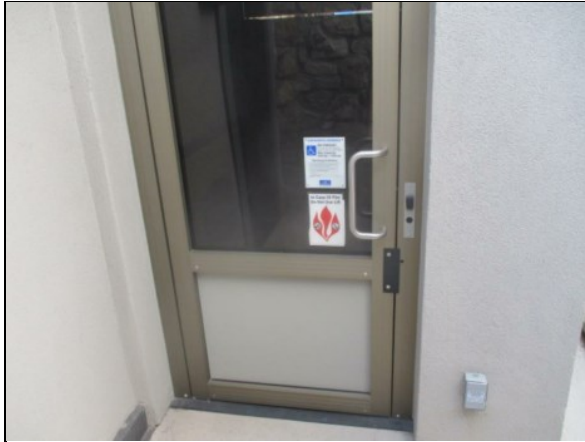
Comp #: 25160 Wheelchair Lift - Replace (Pool)

Comments: Minimal or no subjective/aesthetic value for this component. Useful life is based primarily on normal expectations for service/performance life in this location. Unless otherwise noted remaining useful life expectancy is based primarily on original installation or last replacement/purchase date our experience with similar systems/components and assuming normal amount of usage and good preventive maintenance. Should be inspected for safety and proper function on a regular basis to prevent injury or misuse. Keep moving parts unobstructed and abide by any safety or weight restrictions posted on the device. Vendors report that useful life is not necessarily dependent on level of use although it is a contributing factor. Replacement is sometimes warranted due to lack of available replacement parts etc.

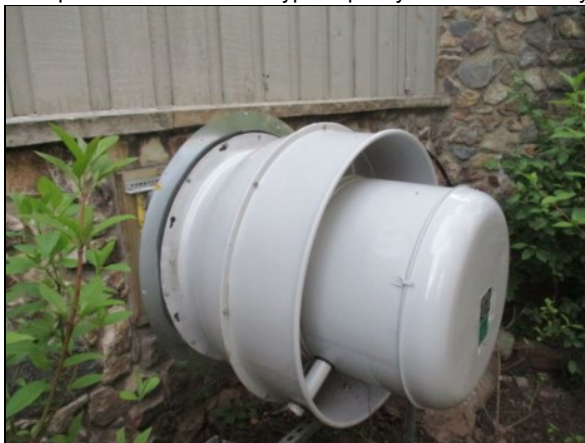
Comp #: 25230 Exhaust Fans – Replace

History: Replaced in 2025 for ~ \$90,000.

Comments: Minimal or no subjective/aesthetic value for this component. Useful life is based primarily on normal expectations for service/performance life in this location. Unless otherwise noted remaining useful life expectancy is based primarily on original installation or last replacement/purchase date our experience with similar systems/components and assuming normal amount of usage and good preventive maintenance. Fans should be inspected and serviced regularly by HVAC vendor or maintenance staff to ensure proper function and to help attain full life expectancy. Motor repair/replacement is typically completed as an Operating expense. At longer intervals we recommend complete replacement of all fans together to obtain better pricing through economies of scale. Pricing shown is based on replacement with same type/capacity as those currently in place.

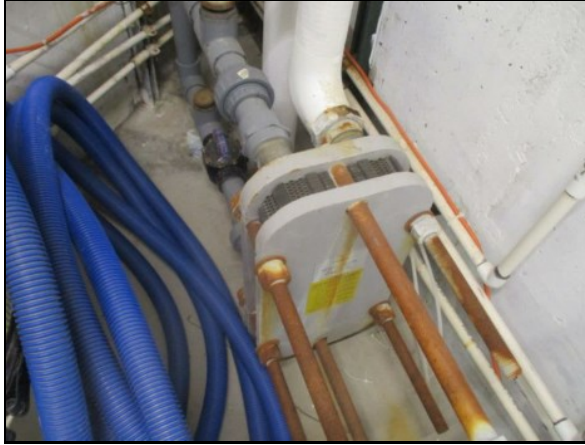
Comp #: 25490 Heat Exchanger - Replace

History: Replaced in 2020.

Comments: Minimal or no subjective/aesthetic value for this component. Useful life is based primarily on normal expectations for service/performance life in this location. Unless otherwise noted remaining useful life expectancy is based primarily on original installation or last replacement/purchase date our experience with similar systems/components and assuming normal amount of usage and good preventive maintenance. Heat exchanger should be inspected and serviced regularly as an Operating expense. In some cases individual parts (i.e. plates for plate heat exchanger units) can be replaced without needing to replace the entire unit. Costs shown here are based on complete replacement unless otherwise noted.

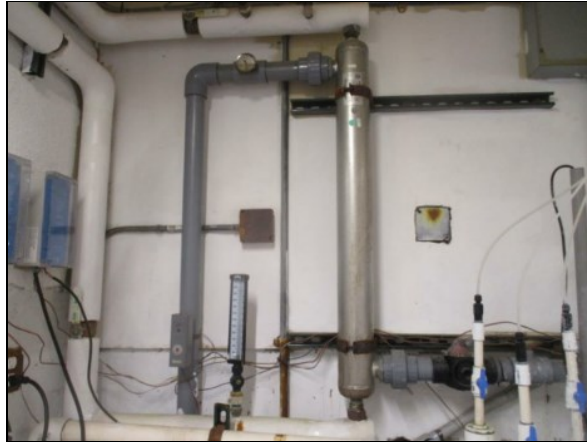
Comp #: 25490 Tube Exchanger - Replace

History: Replaced in 2020.

Comments: Minimal or no subjective/aesthetic value for this component. Useful life is based primarily on normal expectations for service/performance life in this location. Unless otherwise noted remaining useful life expectancy is based primarily on original installation or last replacement/purchase date our experience with similar systems/components and assuming normal amount of usage and good preventive maintenance. Heat exchanger should be inspected and serviced regularly as an Operating expense. In some cases individual parts (i.e. plates for plate heat exchanger units) can be replaced without needing to replace the entire unit. Costs shown here are based on complete replacement unless otherwise noted.

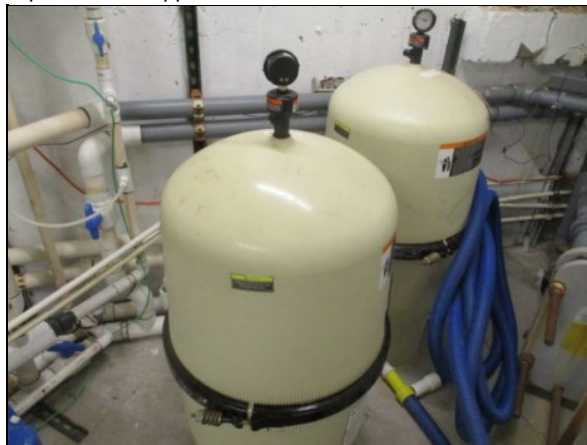
Comp #: 28190 Pentair Cartridge Filters - Replace

History: Replaced in 2020.

Comments: Includes (2) Pentair Clean and Clear Filters (M: CCP420). Vendor should inspect regularly for optimal performance and address any repairs or preventive maintenance as needed. Life can vary depending on location as well as level of use and preventive maintenance. Plan to replace at the approximate interval shown below.

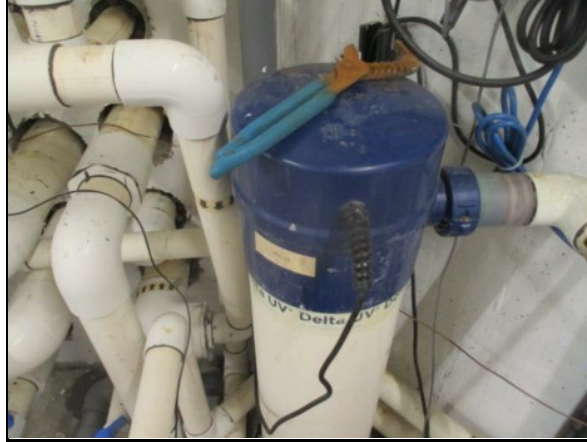
Comp #: 28200 Delta UV Evoqua Filter - Replace

History: Replaced in 2020.

Comments: Pool vendor should inspect regularly for optimal performance and address any repairs or preventive maintenance as needed. Life can vary depending on location as well as level of use and preventive maintenance. In most cases replacement cost does not meet threshold for Reserve funding. Replace as needed within annual Operating budget. Vendor should inspect regularly for optimal performance and address any repairs or preventive maintenance as needed. Life can vary depending on location as well as level of use and preventive maintenance. Plan to replace at the approximate interval shown below.

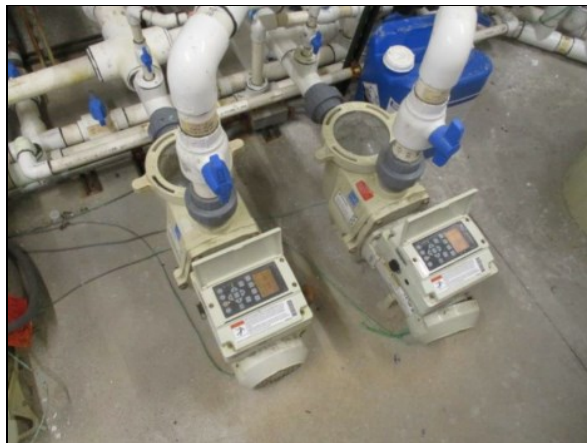
Comp #: 28220 Pentair Pool/Spa Pumps – Repair/Replace

History: Replaced in 2020.

Comments: Includes (4) Pentair IntelliFlo VSF 3HP Pumps. Pumps should be inspected regularly for leaks and other mechanical problems. Cost shown is based on replacement with the same type and size unless otherwise noted and includes small allowance for new piping/valves/other repairs as needed.
